Hughes Warehouse Adaptive Reuse

Project Overview

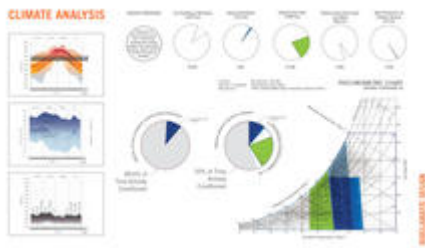
Honoring the history of the building, the design team left the existing double wythe brick walls mostly intact but improved thermal insulation through the addition of R20 rigid roof insulation. The roof was upgraded to a reflective TPO cool roof to mitigate heat gain. Though the original steel frames surrounding the clerestory windows would only accept 1/4-inch laminated safety glass, the new punched windows and curtain wall feature one-inch-thick Solar Band 70 XL coated high-performance glass. Steel window box shades surround the windows along the east and west facades. To mitigate solar gain, the new shades are extruded about a foot on the east side of the building, and about two feet on the west. The clerestories and courtyard curtain wall are equipped with translucent, automated shades that control glare without obscuring views and also abide by the astronomical clock. These combined shading strategies have reduced the amount of time that requires active conditioning by 18.5% per year. The courtyard curtain wall illuminates interiors but is shaded by the preexisting south façade, preventing direct glare. A 65 kW photovoltaic rooftop array generates approximately 46% of the energy needed for building operations.

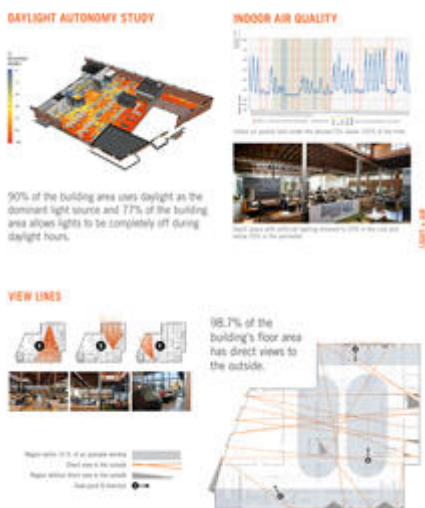
Other than clerestory windows and several loading dock entries, the building was entirely encased in a double wythe brick wall. While the clerestories provided daylight to the interior, they provided only views to the outside of the sky and did not facilitate the transition from streetscape to interior. By adding punched windows along the east and west facades and a glass curtain wall to the newly inserted courtyard, views to the outside are available in 98.7% of the floor area. Additionally, the clerestories, which had been painted over, were made

operable once again, providing natural ventilation to building occupants when desired. 60% of the office floor area is within 15 feet of an operable window, accessible to 48 of 77 full-time employees. CO2 meters monitor indoor air quality, which fall below the threshold for indoor CO2 levels.

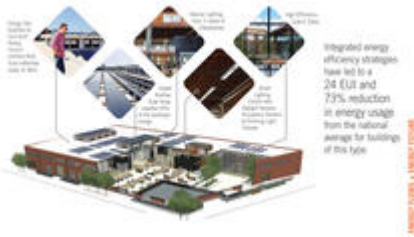
The project integrates sophisticated systems that optimize the building's performance: shade control governed by the astronomical clock, automated lighting sensors that automatically adjust to occupancy and daylight levels, 65 kW solar panel array on the insulated roof that meet about 46% of the building's energy needs, and an HVAC system that allows individual control of each conference room. Solar power is an ideal energy source for San Antonio; as a cooling dominated climate, PVs are at their peak performance during the summer when cooling loads are at their highest. When the building is not occupied, thermostats automatically adjust a standard baseline temperature by +/- 10 degrees to reduce heating and cooling demands. These comprehensive strategies resulted in a 73% reduction from the national average.

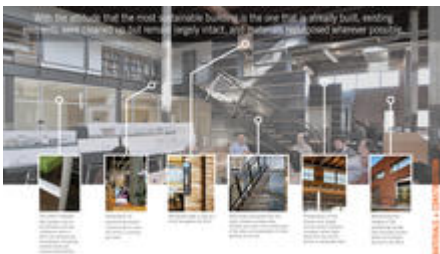
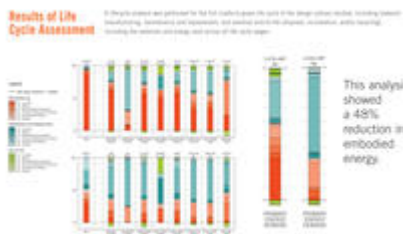
With the attitude that the most sustainable building is the one that is already built, existing elements were cleaned up but remain largely intact. The structure was left exposed to minimize material use, and materials were repurposed wherever possible. Furniture from the previous office was remilled and reassembled to create workstations that supported the open plan. Reclaimed teak was used for doors on meeting pods. Selected in part for their durability, glass and steel components—such as punched windows and a window wall overlooking the courtyard—were integrated into the existing longleaf pine and brick structure, providing natural light and ventilation to interior spaces. Timber salvaged from the roof joists was repurposed as stair treads and for board-formed concrete poured onsite. Sections of otherwise unusable concrete floor became pavers in the alley. Recycling, catering, kitchen, and green cleaning policies have been implemented, as well as a composting program for use in the alley garden.

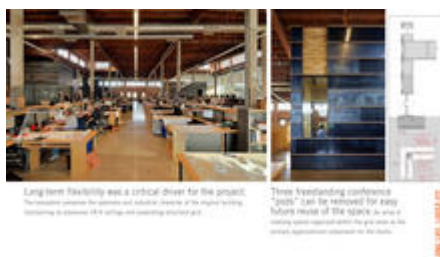
Because the tenant spaces are occupied under leasing agreements, long-term flexibility was a primary focus. The renovation preserves the building's original open plan structural grid. An array of meeting spaces organized within the grid serve as the primary organizational component for the studio. The enclosed meeting spaces consist of a bank of conference rooms at the rear, built of DIRT modular wall systems, which can be removed and reconfigured over time. Three freestanding conference "pods" function as meeting spaces, and can also be removed without altering the building's structure. In addition, none of the office furniture is built in except for kitchen cabinets. These strategies allow the space to easily be reused and reconfigured by future tenants.
